Thompson Pump Caribbean Starts Off In Style with Wellpoint System in Puerto Rico

Gallery Plaza is a new 23-story condominium complex being constructed in San Juan, Puerto Rico, with a projected grand opening in 2008.

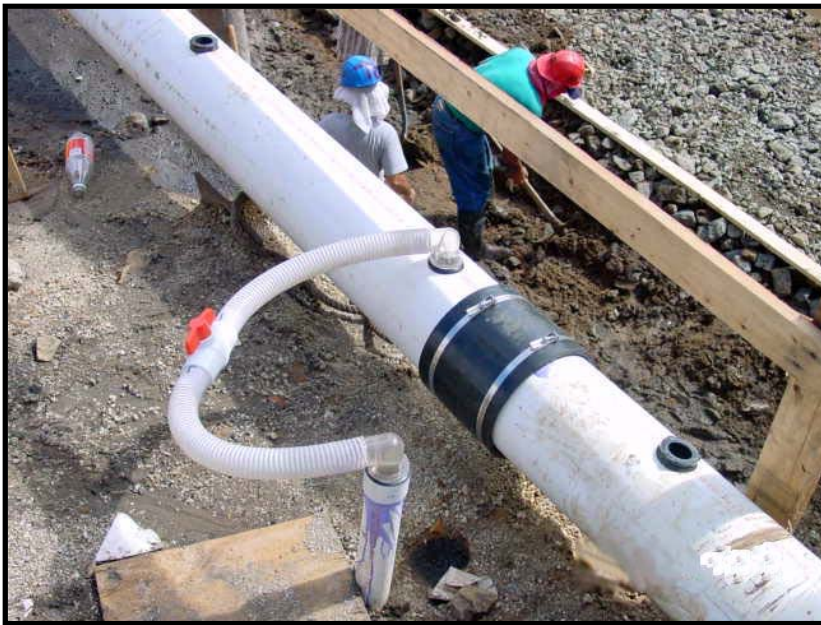
Crews began excavating as the wellpoint system was in operation.

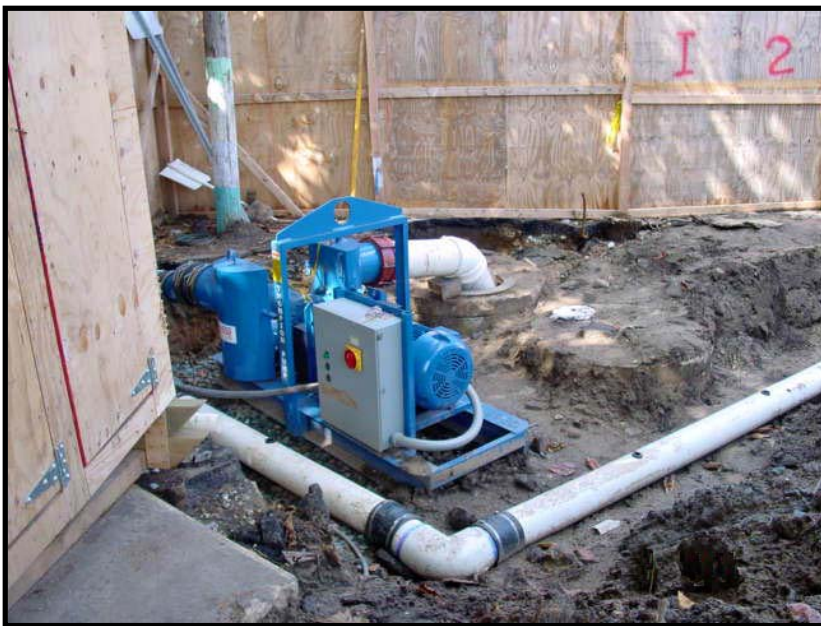
Two 12" Thompson Pump Rotary Wellpoint Pumps were used on the jobsite to remove the groundwater.

The wellpoint system started with two Thompson Pump 12" Rotary Wellpoint Pumps to operate the system, with another 12" Rotary Wellpoint Pump as backup. The wellpoint system also included 1,400' of header pipe with three hundred 2" wellpoints with riser pipe to extend the wellpoints 30' under the ground.

Once the wellpoints and the rest of the wellpoint system was installed and operational, Thompson Pump Caribbean experienced their first obstacle. The Thompson Rotary Wellpoint Pumps were operating perfectly and removed the groundwater at an optimum rate. The Thompson Pump 12" Rotary Wellpoint Pump has a maximum capacity of 3,000-gallons per minute. The groundwater was being directed into a nearby sanitary drain via the discharge pipe from each pump. With the pumps operating efficiently, the team noticed that the sanitary drain was beginning to flood the street and flow back onto the jobsite. The Thompson Pump team redirected the discharge to a nearby storm drain – only to see the groundwater flooding back into the street and the jobsite once again.
