Sinkhole Causes Problems for the Georgia Power Plant Bowen

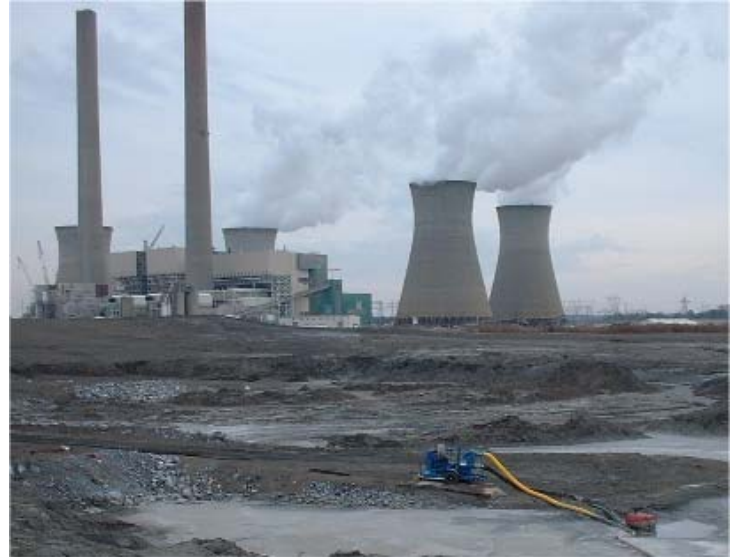
Thompson Pump's 8-inch Dry Prime Open Trash sewage pump dewateres the Power Plant's sinkhole.

The ash site was once a flat piece of land, until a huge sinkhole opened up suddenly earlier in the year. The sinkhole caused 30 to 40-cubic yards of dirt and ash to fall into the enormous sinkhole. The ash, the water from the cooling towers from the power plant, and rainwater all collected in this sinkhole. The power plant required that the sinkhole be dewatered so that they could make plans to repair the sinkhole, and before more flooding occurred.

The Atlanta Service Center provided the power plant with a Thompson Pump 8-inch Dry Prime Open Trash Sewage Pump along with the necessary suction and discharge hoses. The pump was equipped with a Thompson Automatic Start/Stop Control Panel and Float System to allow the unit to operate unattended while the water level in the sinkhole fluctuated due to additional rain and water byproduct.

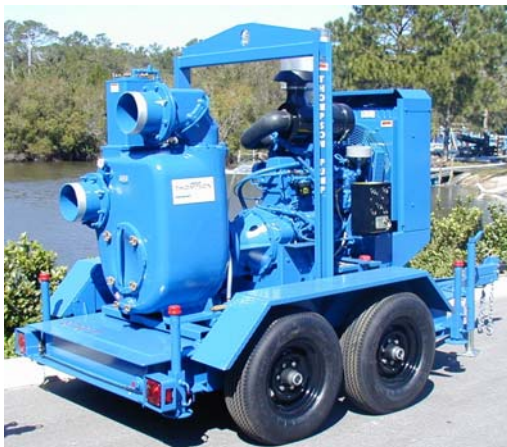
Thompson Pump's 8-inch Dry Prime Open Trash Sewage Pump with removable, enlarged clean-out cover, enlarged fuel tank guaranteed for over 24-hour operation, and modular design.
